# Microscopic studies of wolfram carbide after fracturing

Frøyland Øyvind, Moxnes John F

FFI/RAPPORT-2004/01883

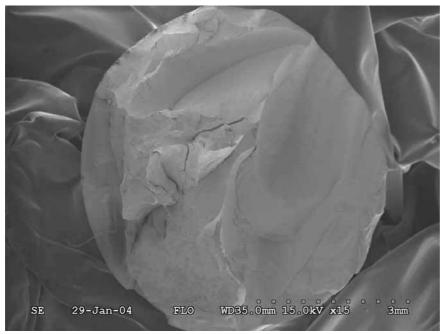
After compression in a simple compression test the hardcore fractured in many different pieces, and the fragments were collected for microscopic examination. The WC-Co hardmetals tested were made by two different manufacturers. The fracture surface is shown in figure 3.1

Figure 3.1: Overview of fracture surface (Sandvik Hard Materials)

We observe that the geometric shape of the WC grains are clearly visible. This indicates that the fracture is mainly intergranular. Also notice that the overall fracture surface is more

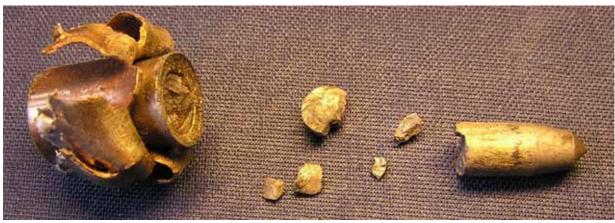
The explosive in the projectile was statically ignited with a squib (M100). The fractured hardcore is seen in figure 5.1. The hardmetal was examined in a scanning electron microscope. Figure 5.2 shows the fracture surface.

Figure 5.1: Projectile after ignition of explosive (H764).

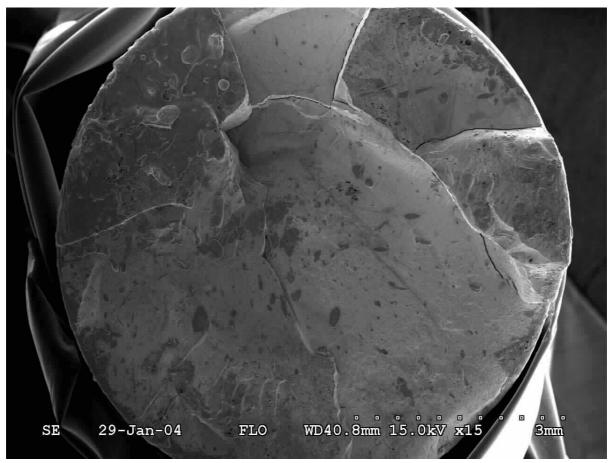
Figure 5.2: Overview of fracture surface from the specimen to the right in figure 5.1.

Again the fracture seems to be mainly intergranular. The fracture surface has also been contaminated with debris from the explosion.

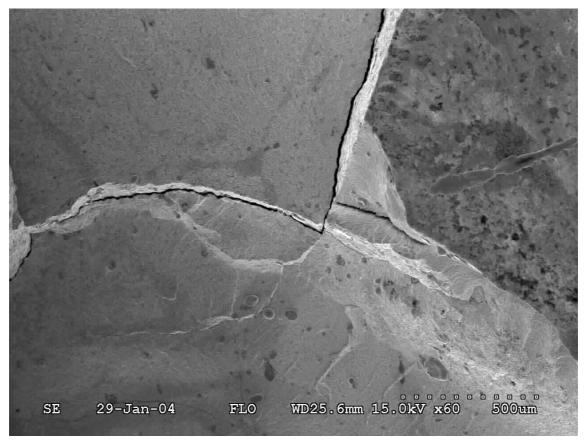
Figure 5.2: Fracture surface with cracks.

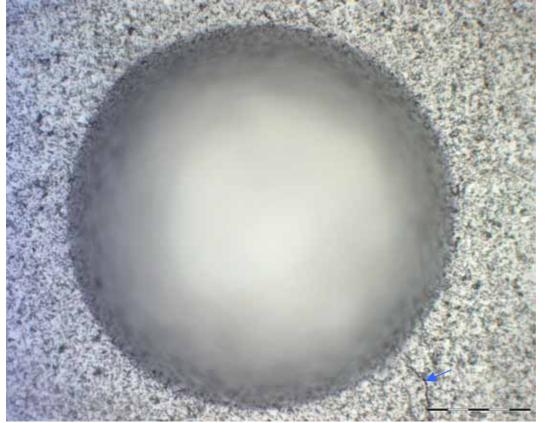
*Figure 7.8: Hertel, Rockwell at 45 kg major load, crack emanating from the lower right edge.*

Cracks were observed for 30 kg with Vickers and in one instance for Rockwell with a major load of 45 kg (HR45N). The cracks observed in the Vickers indentations started in the corners. Data from all the hardness measurements are presented in the appendix section.
