Tests of Hesco shelters November 2010

Norwegian Defence Research Establishment (FFI)

FFI-rapport 2011/01276

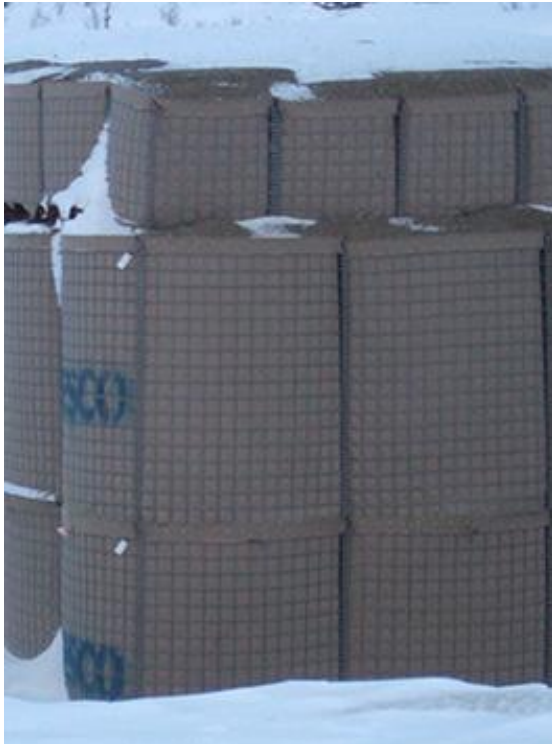
Figure 1.1 Hesco units

Hesco Bastion Concertainer units [1] are field fortifications extensively used by Norway and other countries for force protection. A Hesco unit consists of geotextile covered with a mesh of steel wires, see figure 1.1. The units are made in different sizes, and usually several units are joined together. They can form simple walls or be a part of or cover a complete structure. At the place of erection the units are filled with available soil materials.

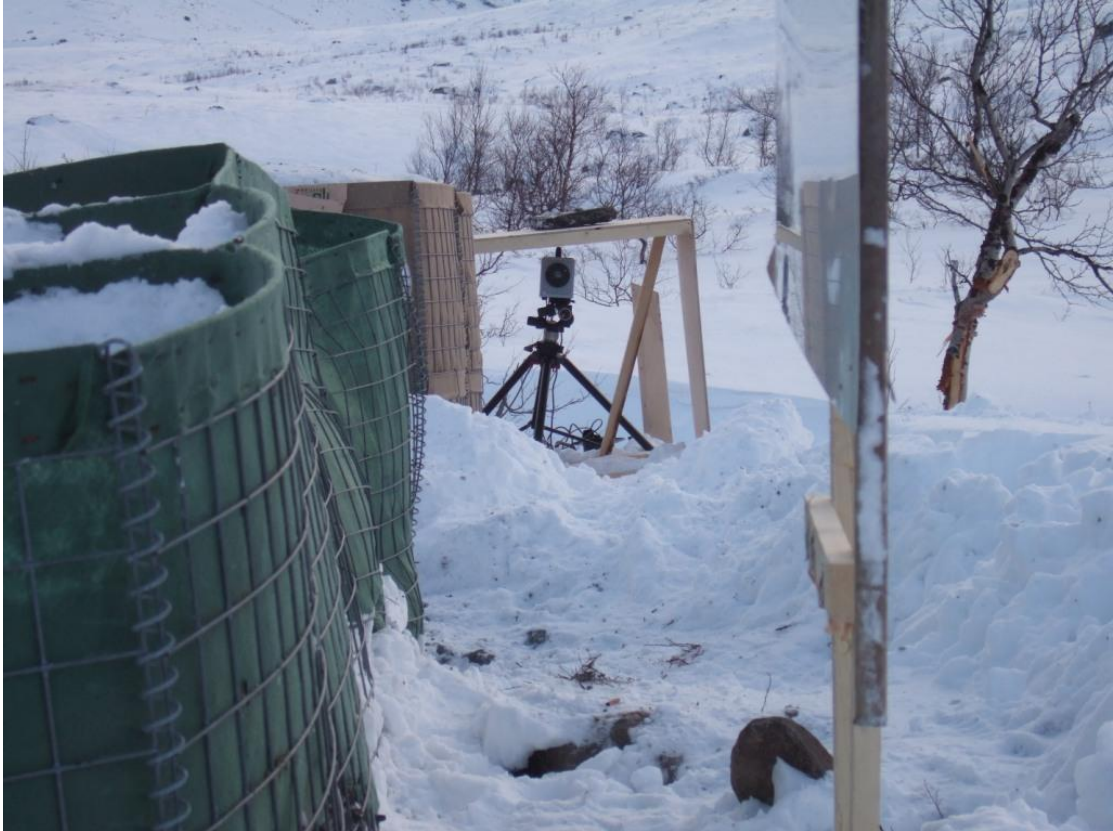
A high-speed video camera filmed the back side of the walls during the explosion in test number 1.1, 1.2 and 1.4, see figure 2.1.

Figure 2.1 High-speed video camera used in test 1

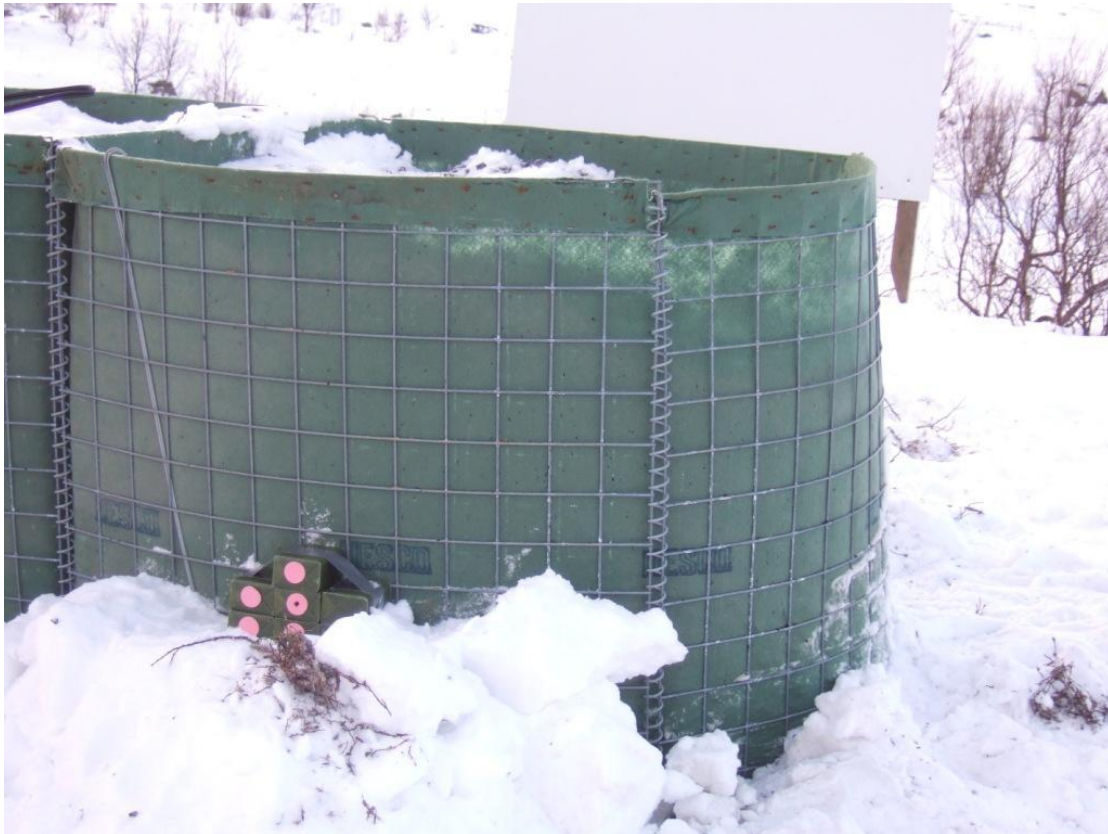
Pictures of the walls and the charges are shown in figures 2.2-2.6. Witness plates of aluminium (1 m x 1 m x 0.001 m) were set up behind the walls to register debris.

Figure 2.2 Setup of test 1.1 with 3.5 kg TNT

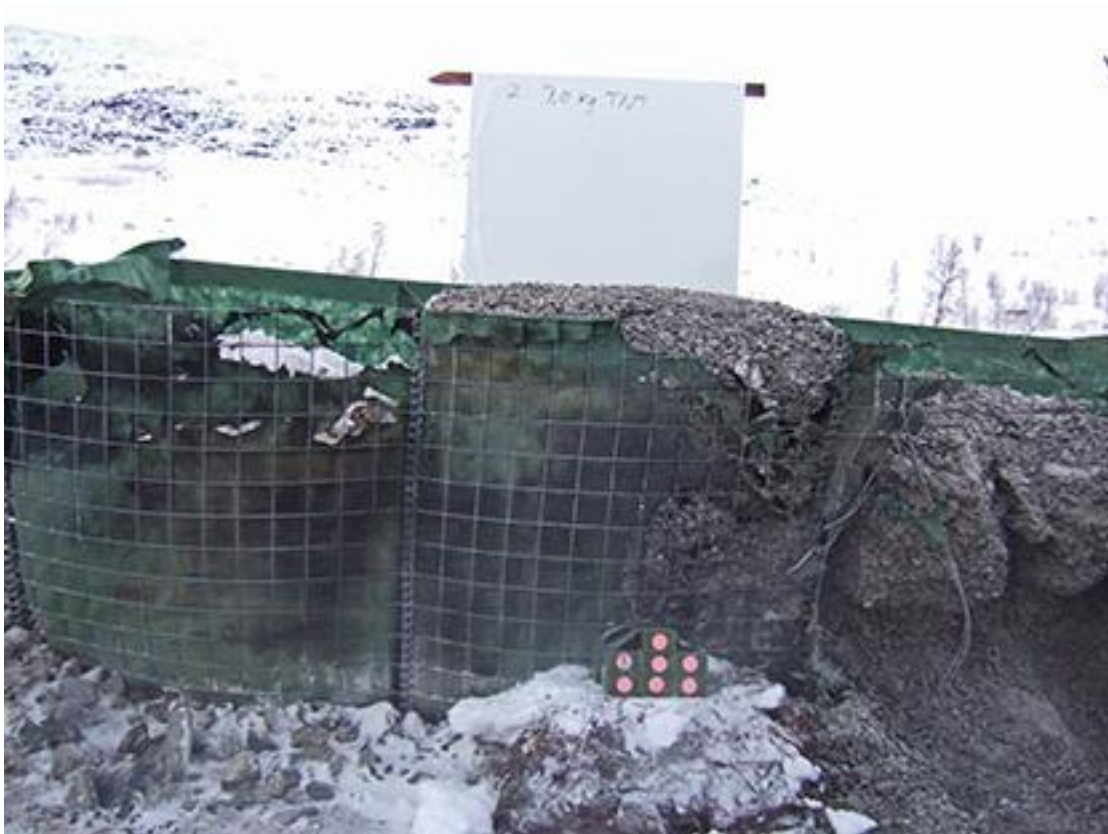
Figure 2.3 Setup of test 1.2 with 7.0 kg TNT

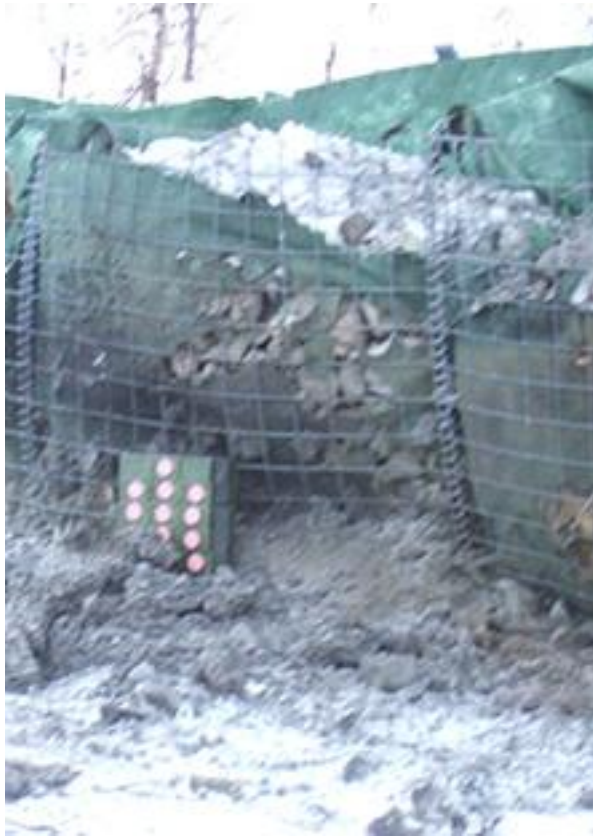
Figure 2.4 Setup of test 1.3 with 7.5 kg TNT

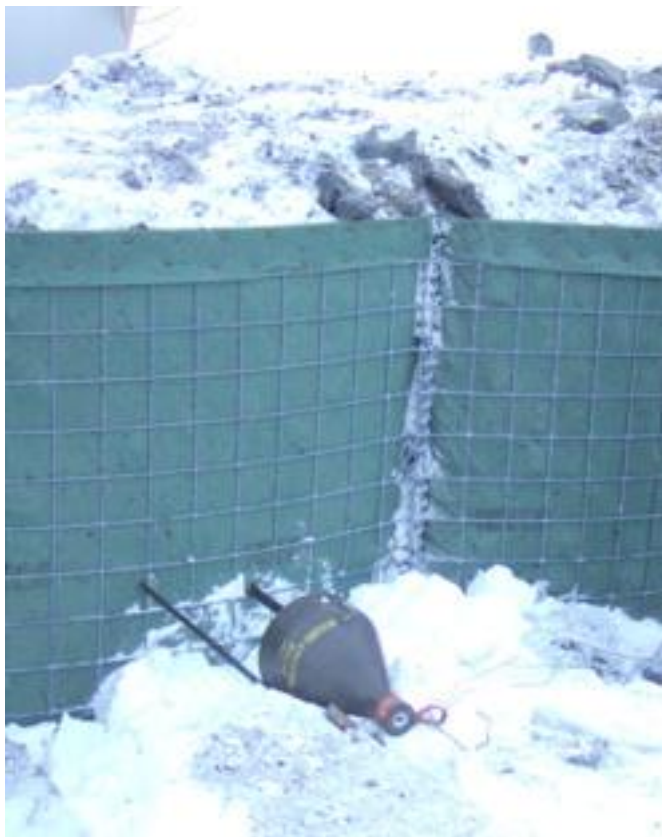
Figure 2.5 3.5 kg shaped charge in test 1.4

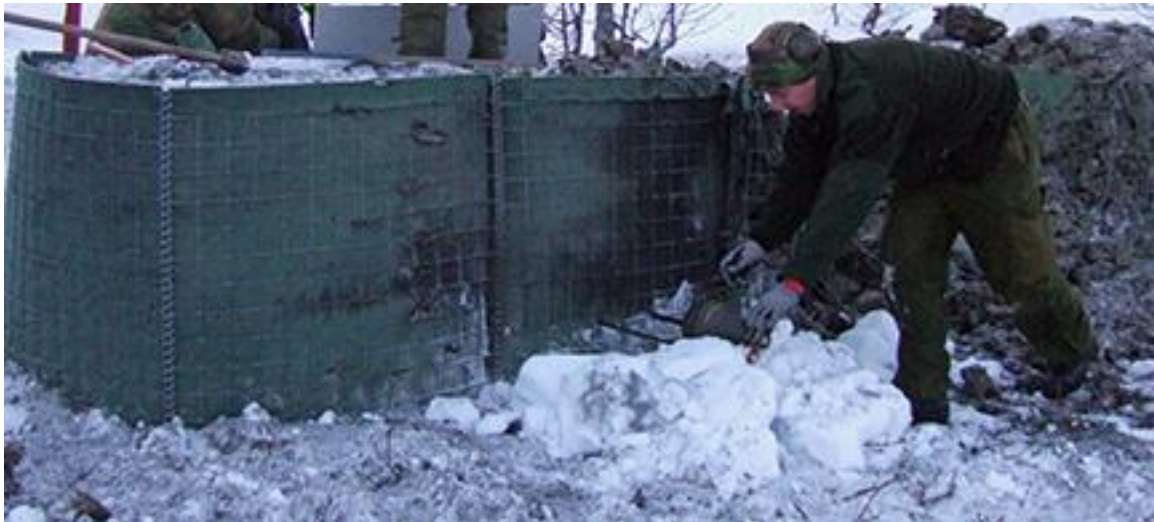
Figure 2.6 Position of 3.5 kg shaped charge in test 1.5

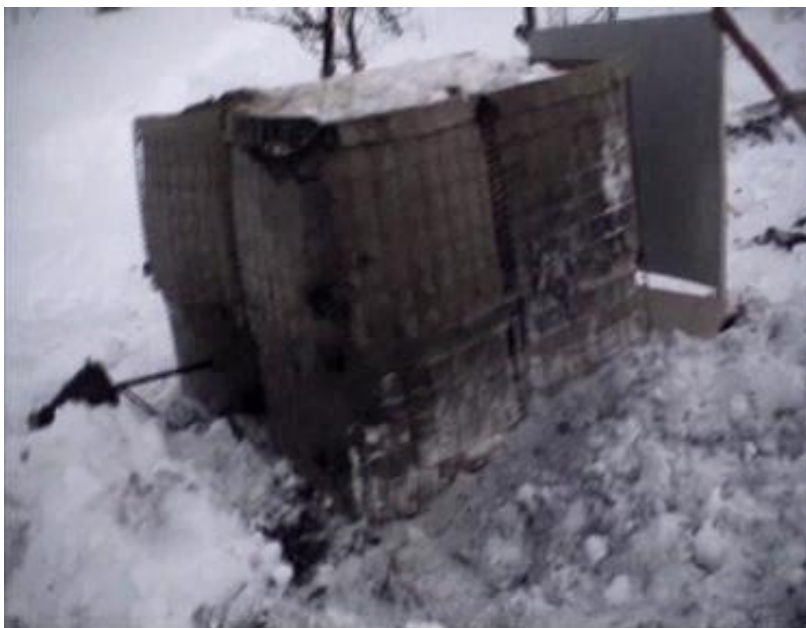
Test 1.6 was different from the other shots of test 1 because in this test MIL 2 units were set up in a 2 x 2 x 2 configuration, see figure 2.7. A MIL2 cell is cubic and has side lengths of 0.61 m. The barrier was tested with a 3.5 kg shaped charge.

Figure 2.7 Setup of test 1.6 with a 3.5 kg shaped charge

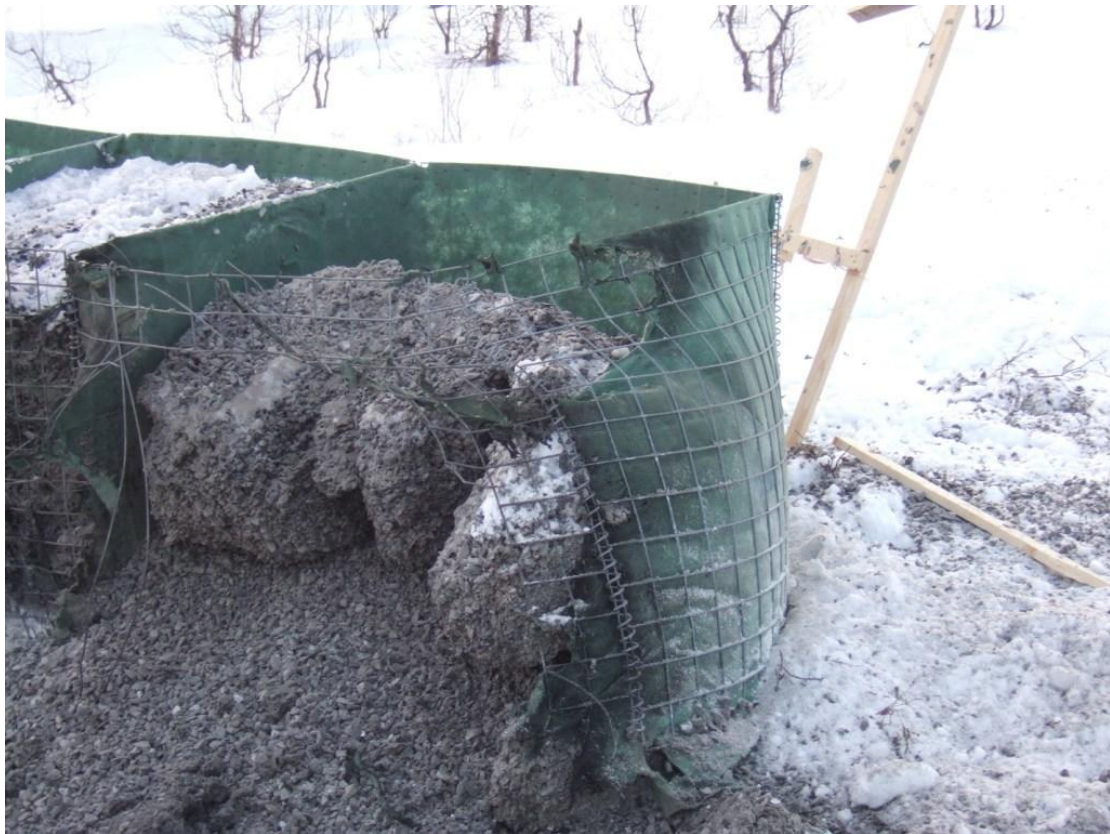
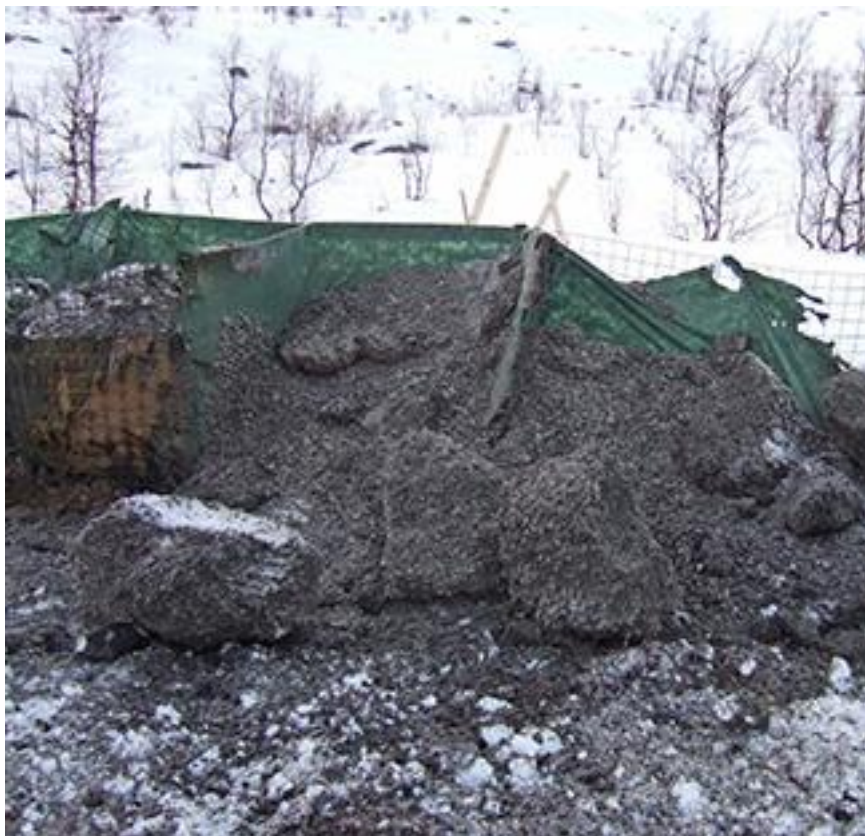
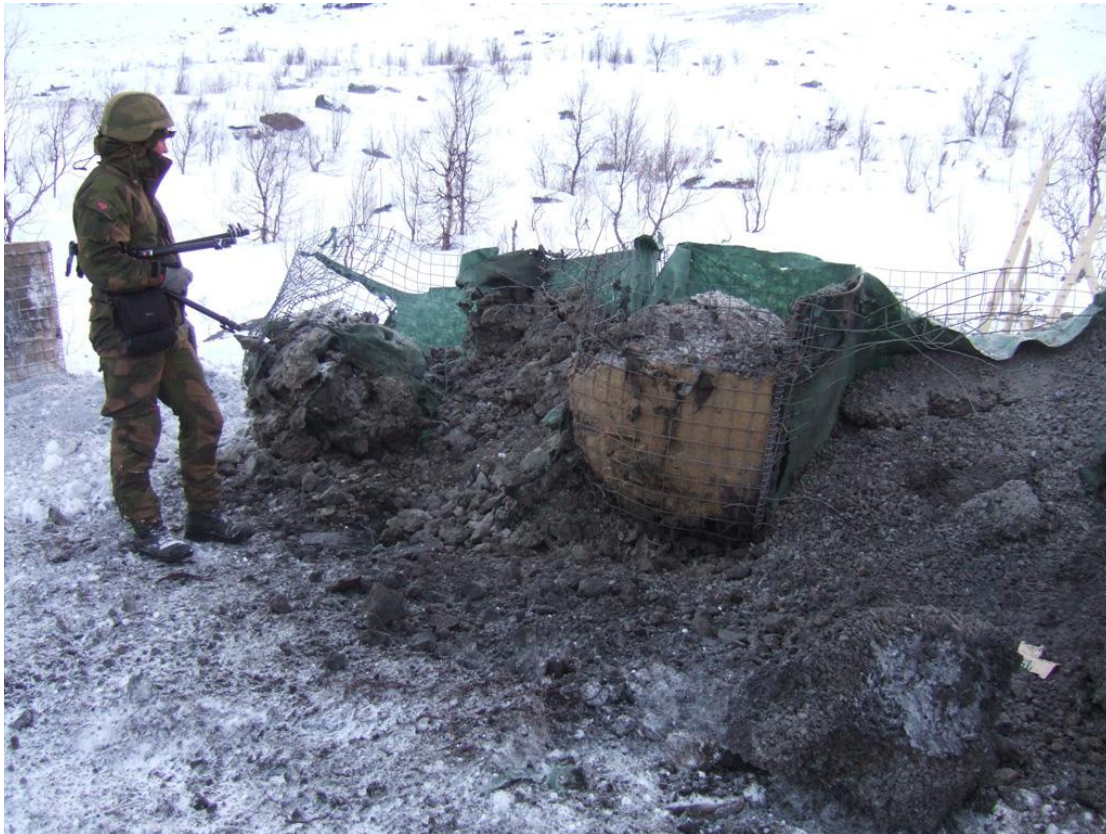
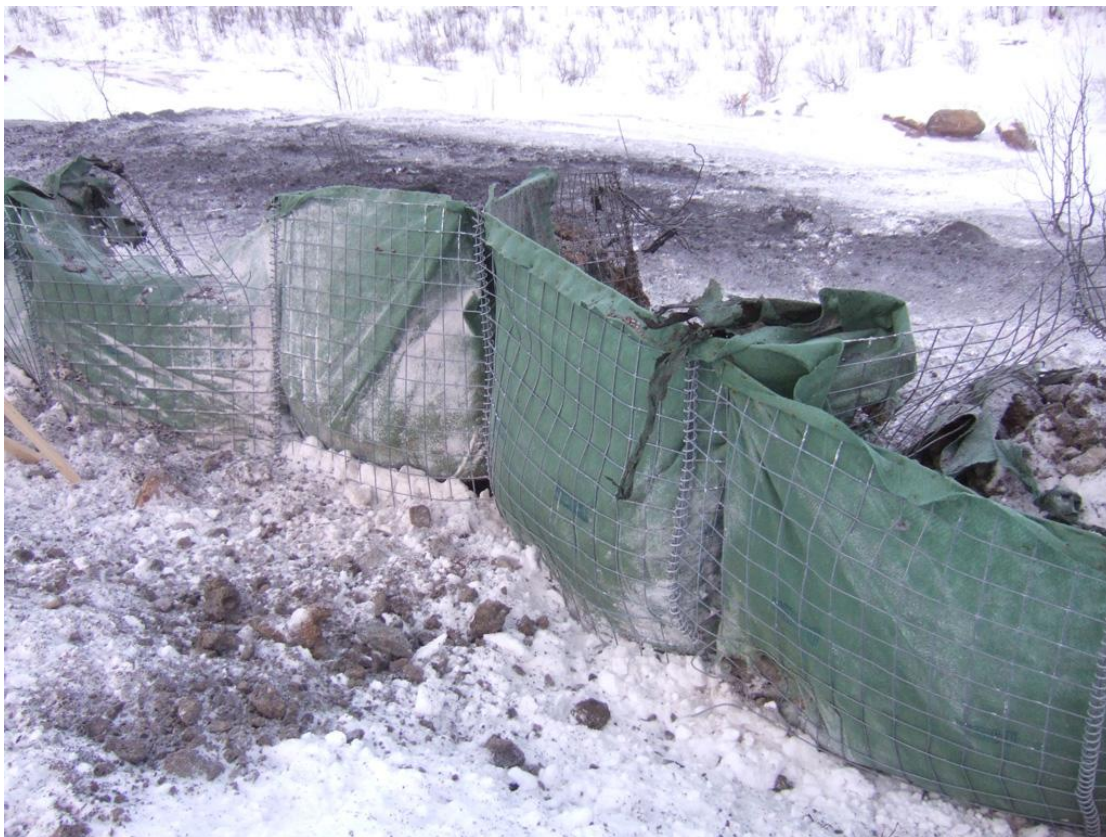
In the tests with TNT slabs of a total mass of 3.5 kg or 7.0 kg, the front side of the walls collapsed, but there was no penetration through the walls. Several stones were thrown out from the top of the walls, yet no holes were made in the witness plates. There was some more debris with crushed rock than with gravel in the walls. Figures 2.8-2.11 show pictures of the walls after the detonations.

Figure 2.8 Front side of wall after test 1.1

Figure 2.9 Front side of wall after test 1.2

Figure 2.10 Front side of wall after test 1.3

Figure 2.11 Back side of wall after test 1.3

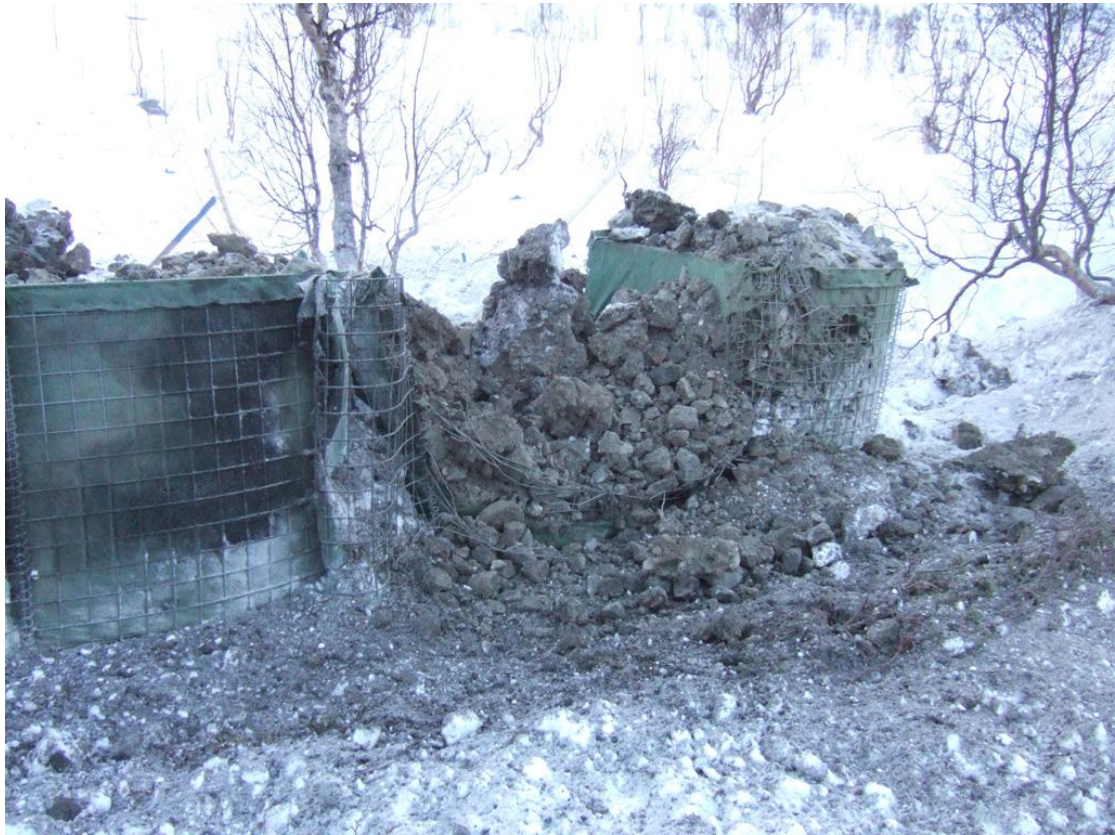
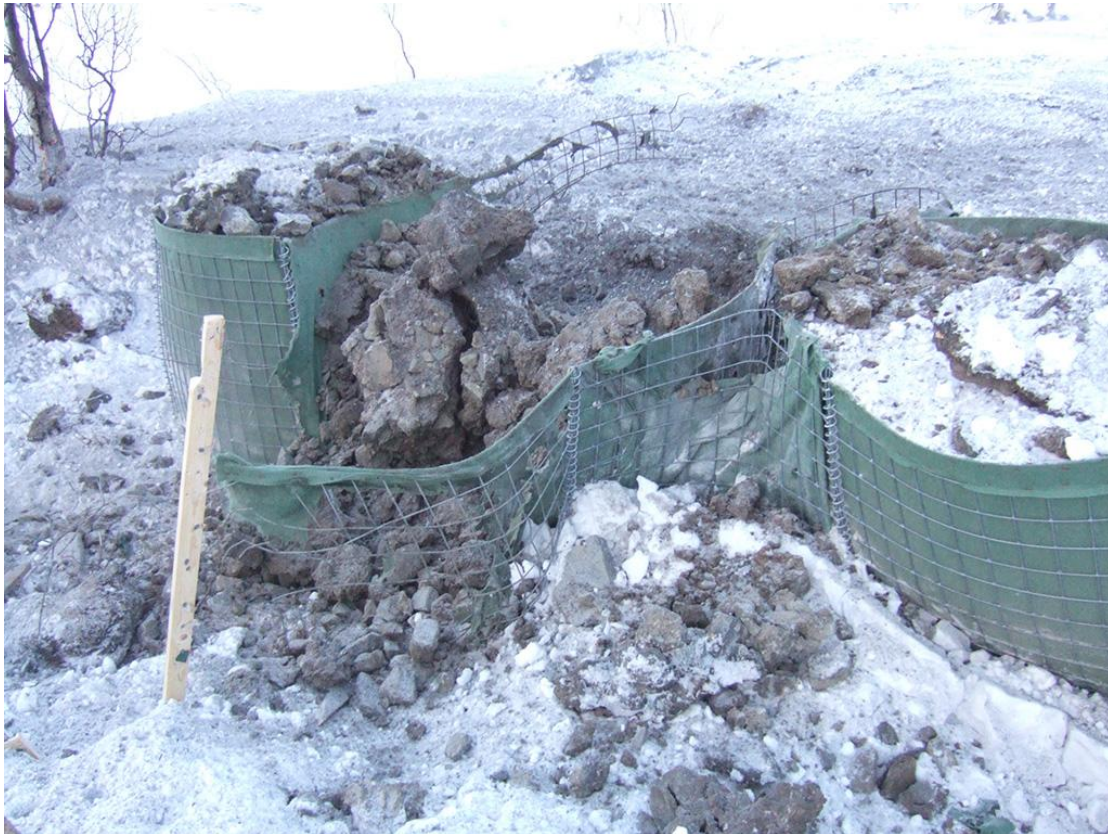
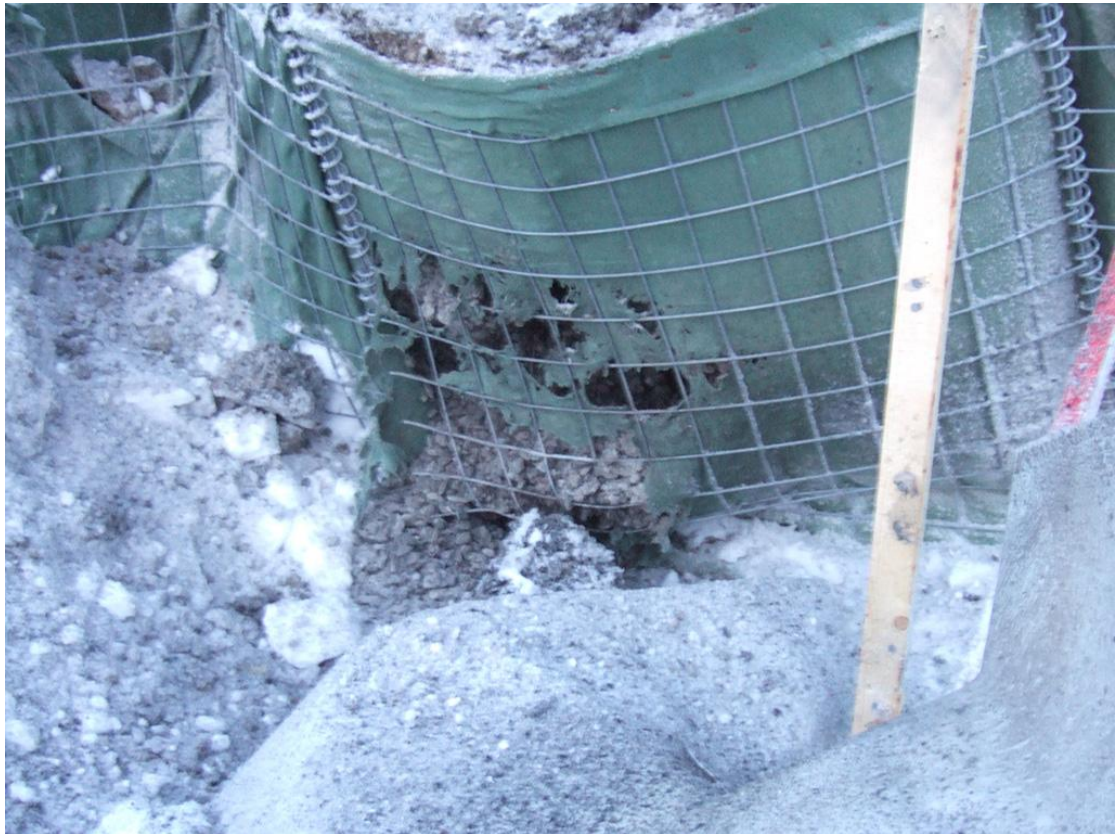
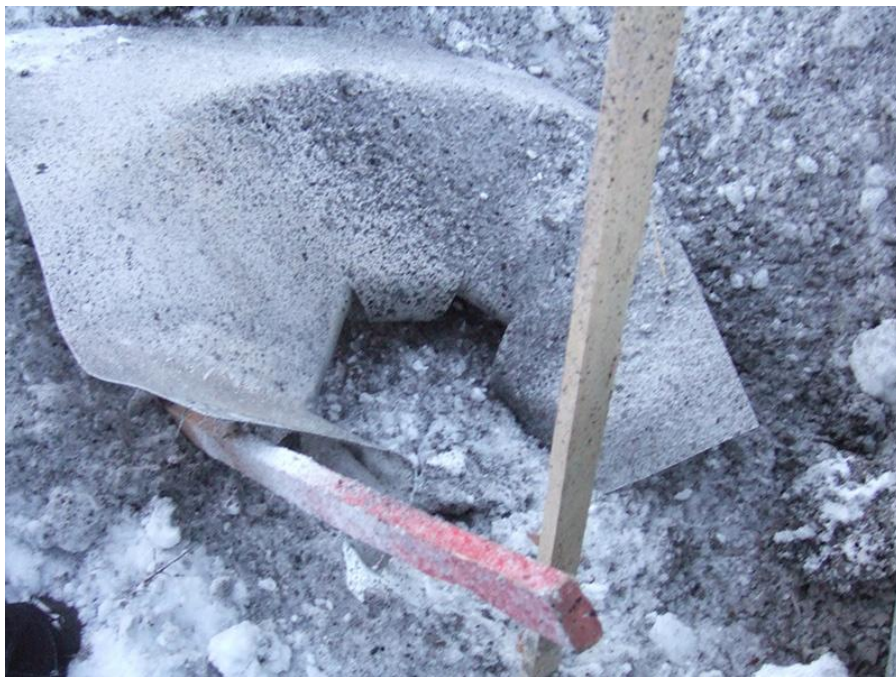
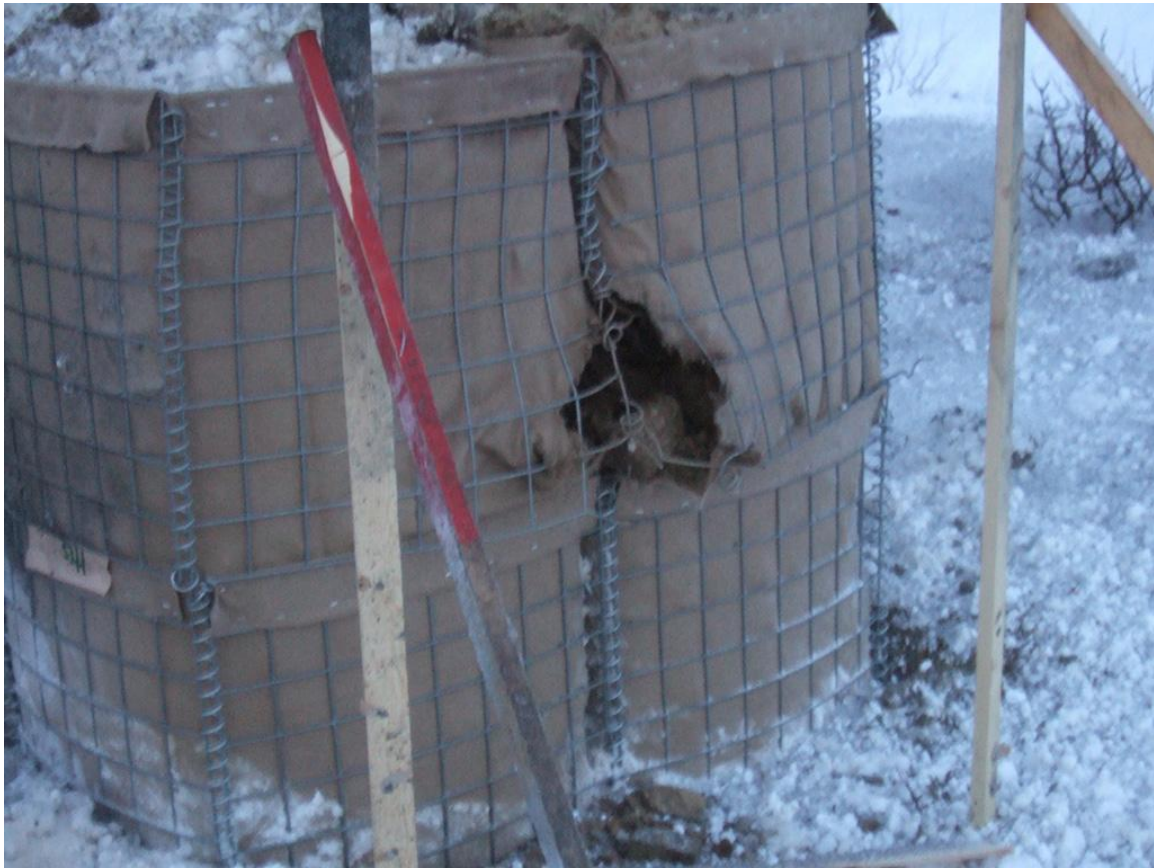
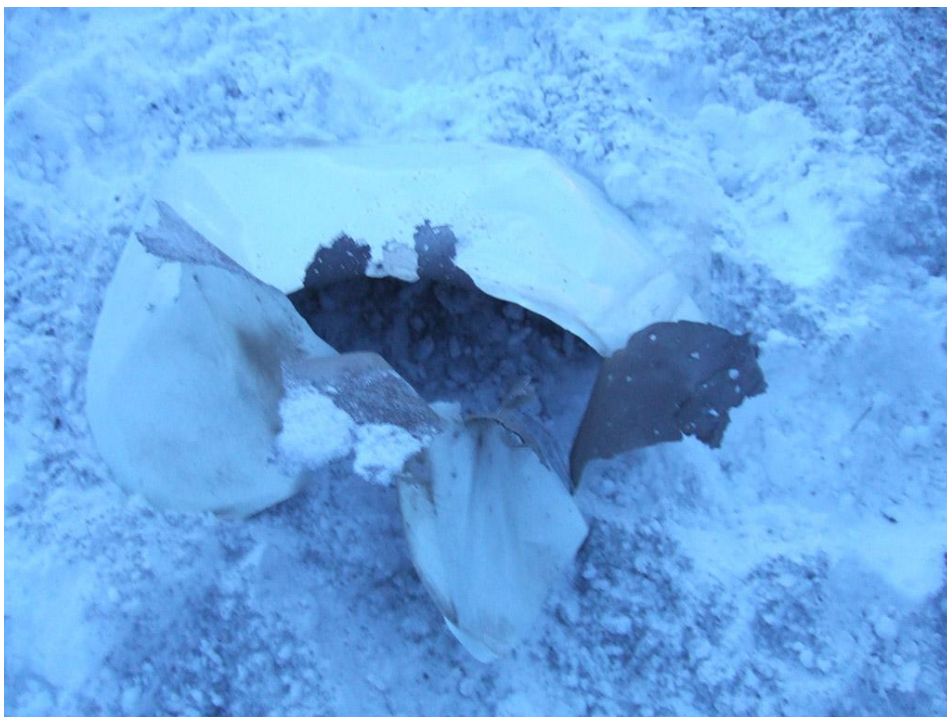
The shaped charges caused penetration of both the walls and the witness plates. This was also the case with the double wall in test 1.6. In addition the witness plates were penetrated by stones, see figures 2.12-2.18.

Figure 2.12 Front side of wall after test 1.4

Figure 2.13 Back side of wall after test 1.4

Figure 2.14 Witness plate after test 1.4

Figure 2.15 Back side of wall after test 1.5

Figure 2.16 Witness plate after test 1.5

Figure 2.17 Back side of wall after test 1.6

Figure 2.18 Witness plate after test 1.6

The debris from the walls perforated by the shaped charges was clearly more extensive than the debris produced by the ordinary charges. The largest stones were thrown farthest away, but also the amount of debris increased with the grain size.

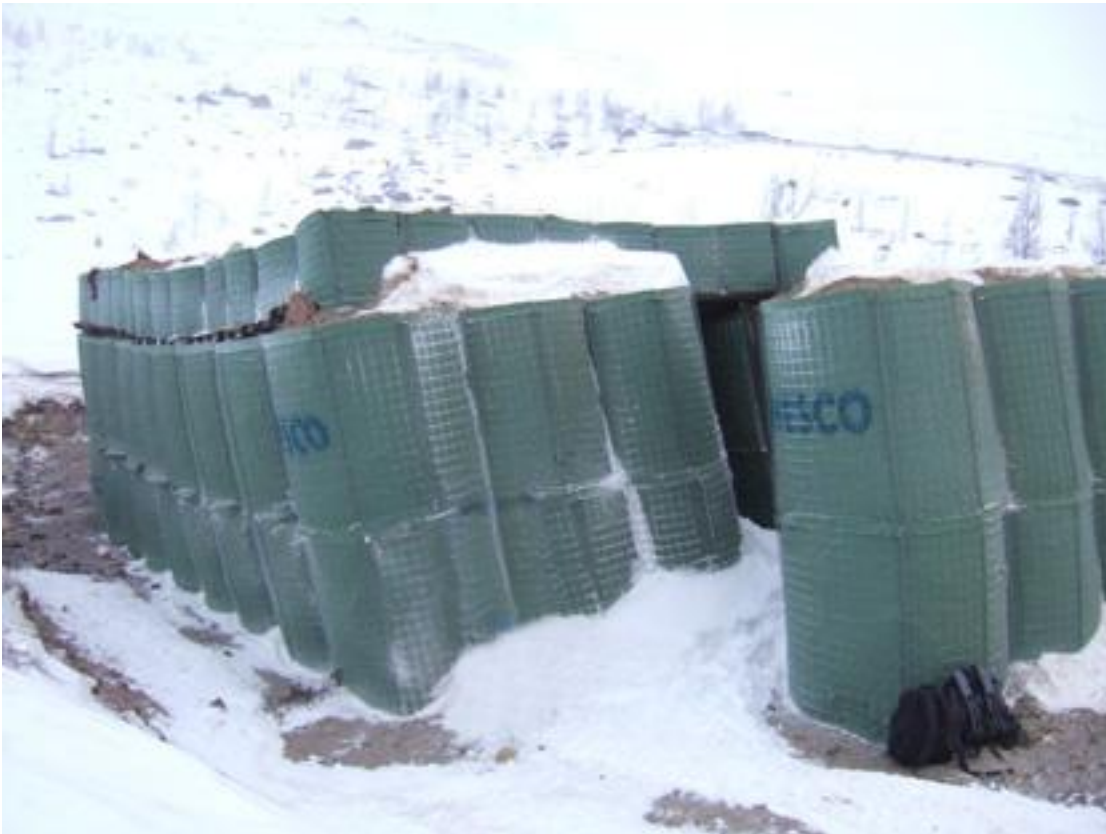
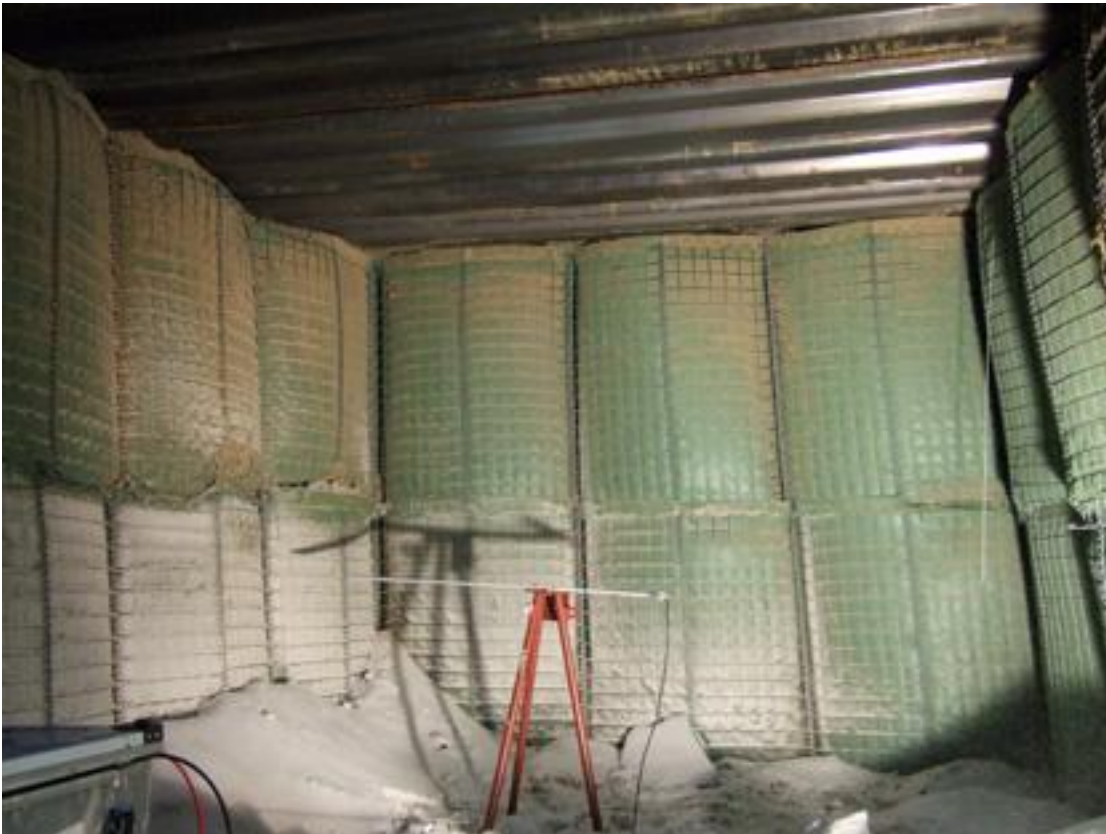
In test 2 charges were detonated at the side and on the top of a UTOPS shelter. This type of shelter consists of MIL 1 walls (1.06 m depth) and a roof of piled steel covered with a layer of MIL 2/5 cells (0.61 m height). The cells in the wall and in the roof were filled with in situ soil material. Figure 2.19 and 2.20 show pictures of the shelter.

Figure 2.19 Entrance of the UTOPS shelter

Figure 2.20 Inside of UTOPS shelter

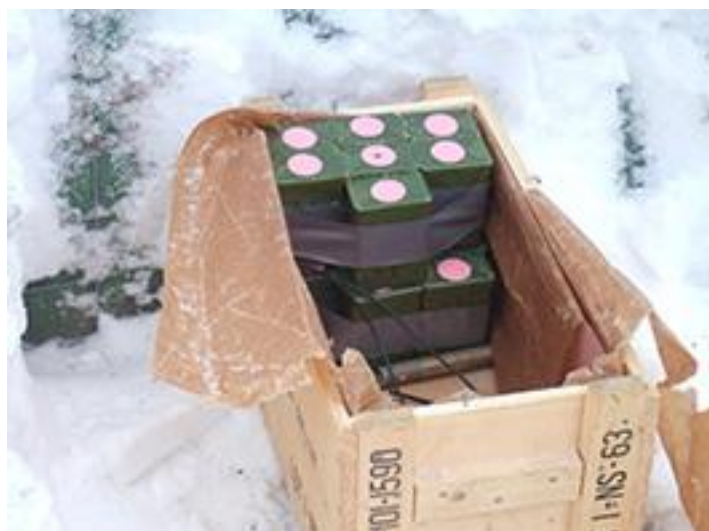
Figure 2.22 shows the charge used in test 2.4.

Figure 2.22 Charge setup in test 2.4

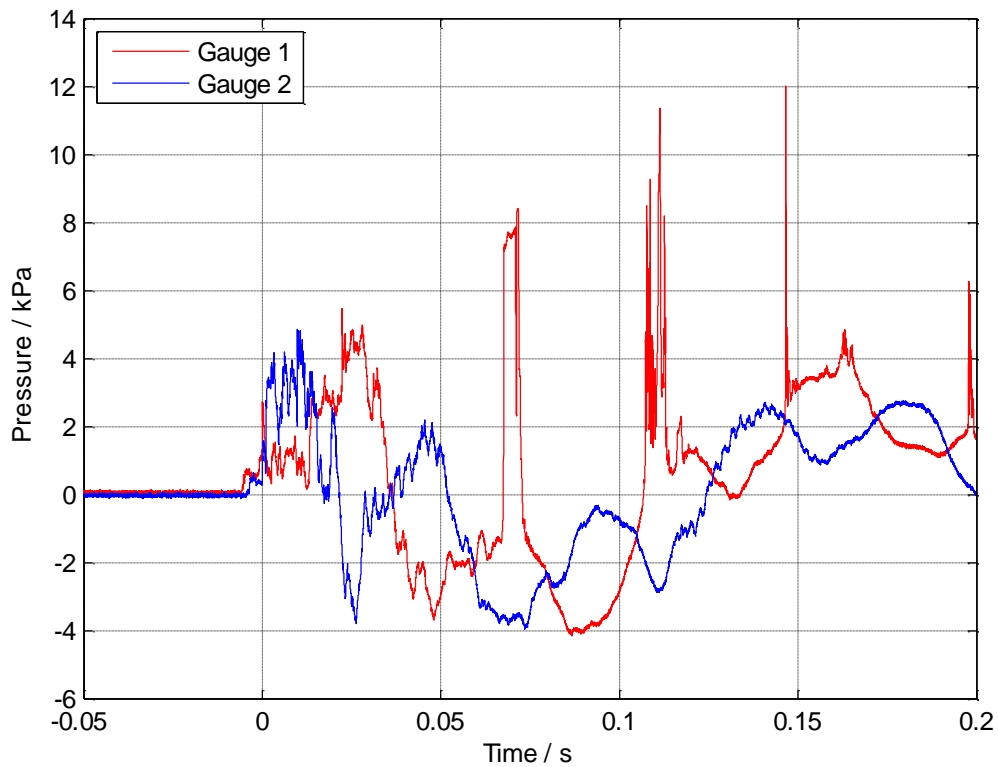
Figure 2.24 Pressure recordings in test 2.3

In test 2.3 the maximum pressure values up to 0.05 s were 5.5 kPa for gauge 1 and 4.9 kPa for gauge 2. The subsequent recordings are the result of several reflections, and gauge 1 gives a maximum pressure of 12 kPa at 0.146 s. At later times the pressure values at gauge 1 reaches 28 kPa.

The first positive phase of the pressure at gauge 1 from -0.006 s gave an impulse of 86 Pas during the 45 ms duration. At gauge 2 the first pressure wave arrived 2 ms later and had a duration of 26 ms and an impulse of 52 Pas. The second and third positive phase of the pressure at gauge 1 produced impulse values of 33 and 43 Pas respectively.

When 3.5 kg TNT was detonated on the roof of the UTOPS shelter, the maximum pressure inside was measured to almost 3 kPa. With a 7.5 kg charge the value of the first peak was around 5 kPa. Then reflections lead to larger pressure values. With a 7.5 charge at the side of the shelter the maximum pressure of 2.6 kPa was measured at the first peak.

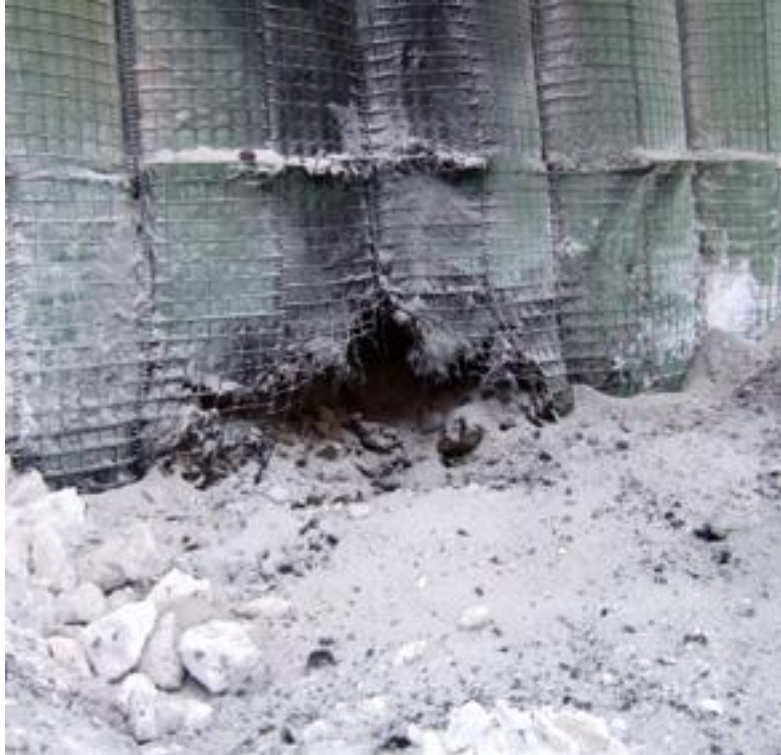
The charges produced craters in the roof or in the wall. After test 2.3 the crater depth was 50 cm. The crater in the wall after test 2.4 had a depth of 0.45 m, the width was 1.0 m, and the height 0.7 m, see figure 2.26.

Figure 2.26 Crater in the wall after test 2.4

The craters in the roof and in the wall of the UTOPS shelter did not break through. This is similar to the results for the MIL 3 walls, but there was no ice in the wall at which the charge of test 2.4 was detonated. The roof of the shelter was open for snow and rain.

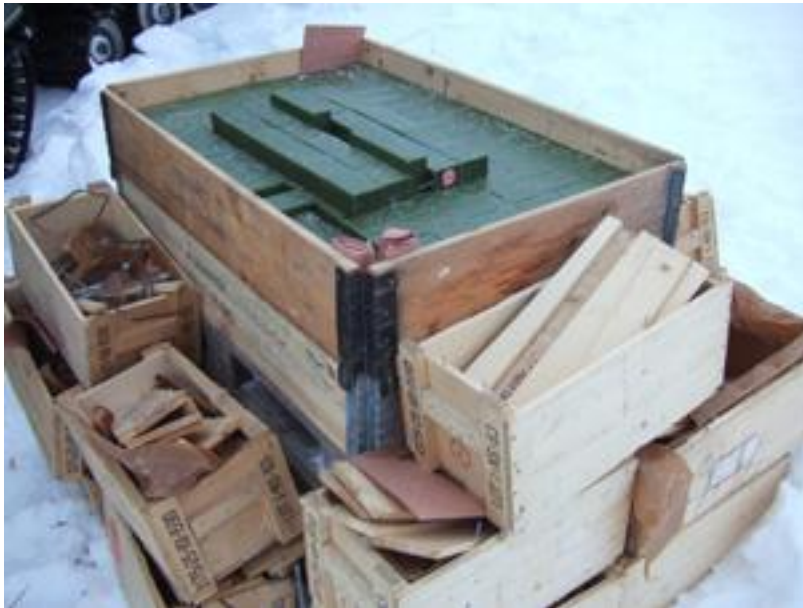
In test 3 a charge of 420 kg TNT was detonated 20 m from a MIL 10 wall placed on the ground beside a MIL 10 wall buried 0.5 m below the ground. A MIL 10 wall is 1.52 m deep and 2.12 m high, and the width of each wall was 15 m (ten cells). The walls were filled with local soil, which consisted of sand, silt and some stones. The charge simulated a car bomb (VBIED).

Figure 2.27 Charge in test 3

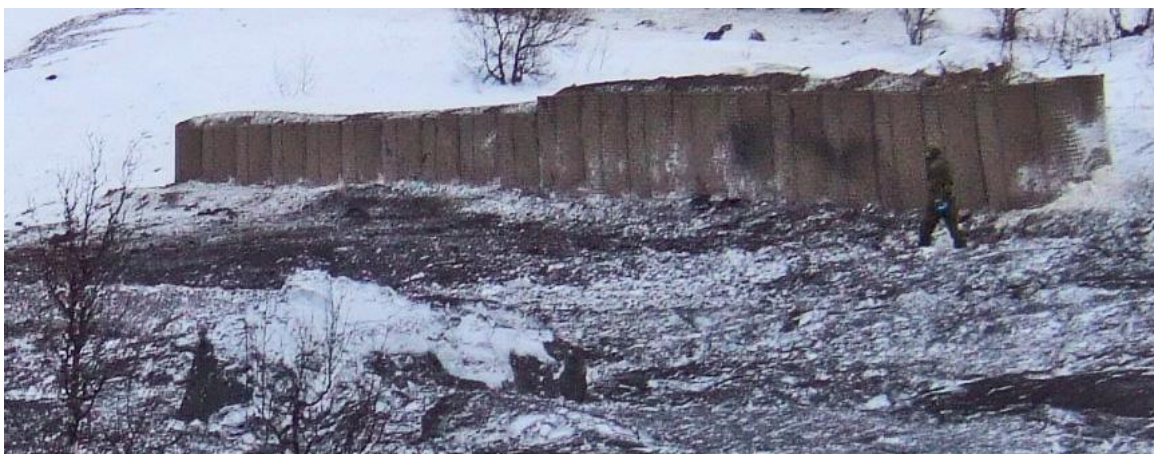
The detonation of 420 kg TNT did not make any harm to the MIL 10 barricades, see figure 2.28.

Figure 2.28 MIL 10 walls after test 3

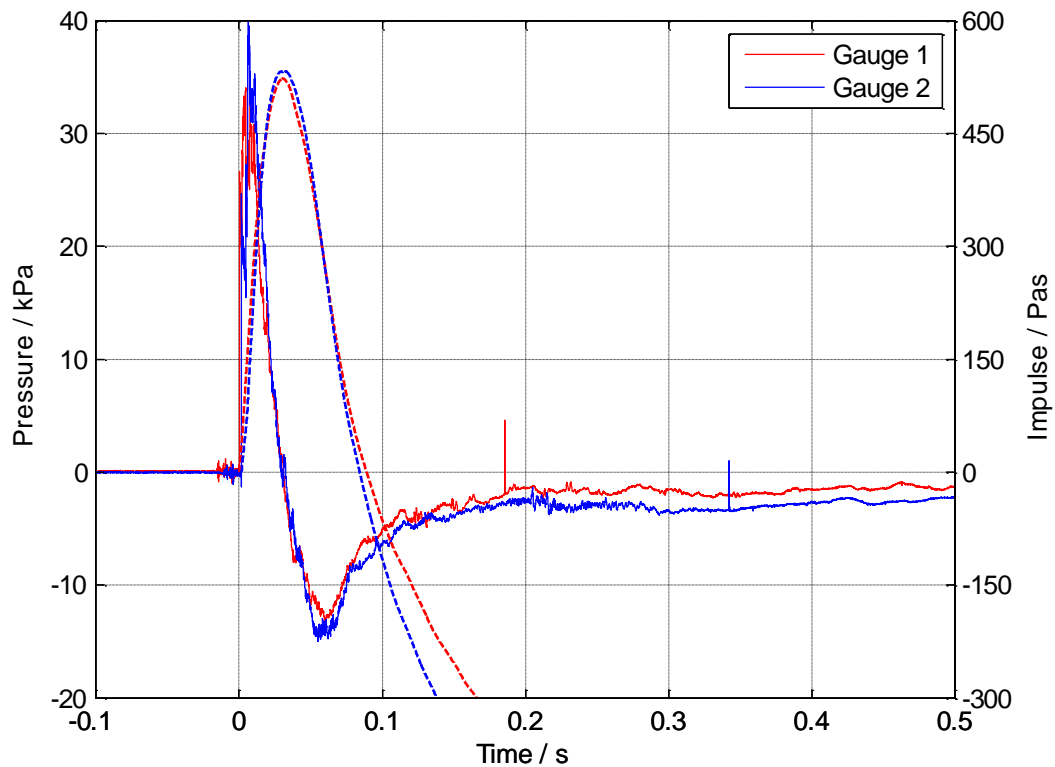
The pressure recorded 3 m behind the wall is shown in figure 2.29.

Figure 2.29 Recorded pressure (solid lines) and impulse (dashed lines) in test 3

Gauge 1 registered the pressure behind the buried wall, and gauge 2 behind the unburied wall. The maximum pressure was 34 kPa at gauge 1 and 40 kPa at gauge 2. After the test it was discovered that gauge 1 was rotated with the sensor pointing almost downwards. The duration of the positive phase of the pressure wave was 31 ms at gauge 1 and 28 ms at gauge 2. The pressure wave arrived at gauge 2 1.7 ms after the arrival at gauge 1. The impulse of the positive phase was 520 and 530 Pas for the two gauges.

Since the pressure wave from detonation of 420 kg TNT is assumed to propagate about normally over the MIL 10 wall, the pressure gauges probably registered values of the first pressure wave close to incident pressure values. The direction of the subsequent pressure waves is more difficult to assume with the uneven terrain, and the pressure values are more difficult to interpret. There are however no signs of any pressure leakage below the unburied wall.

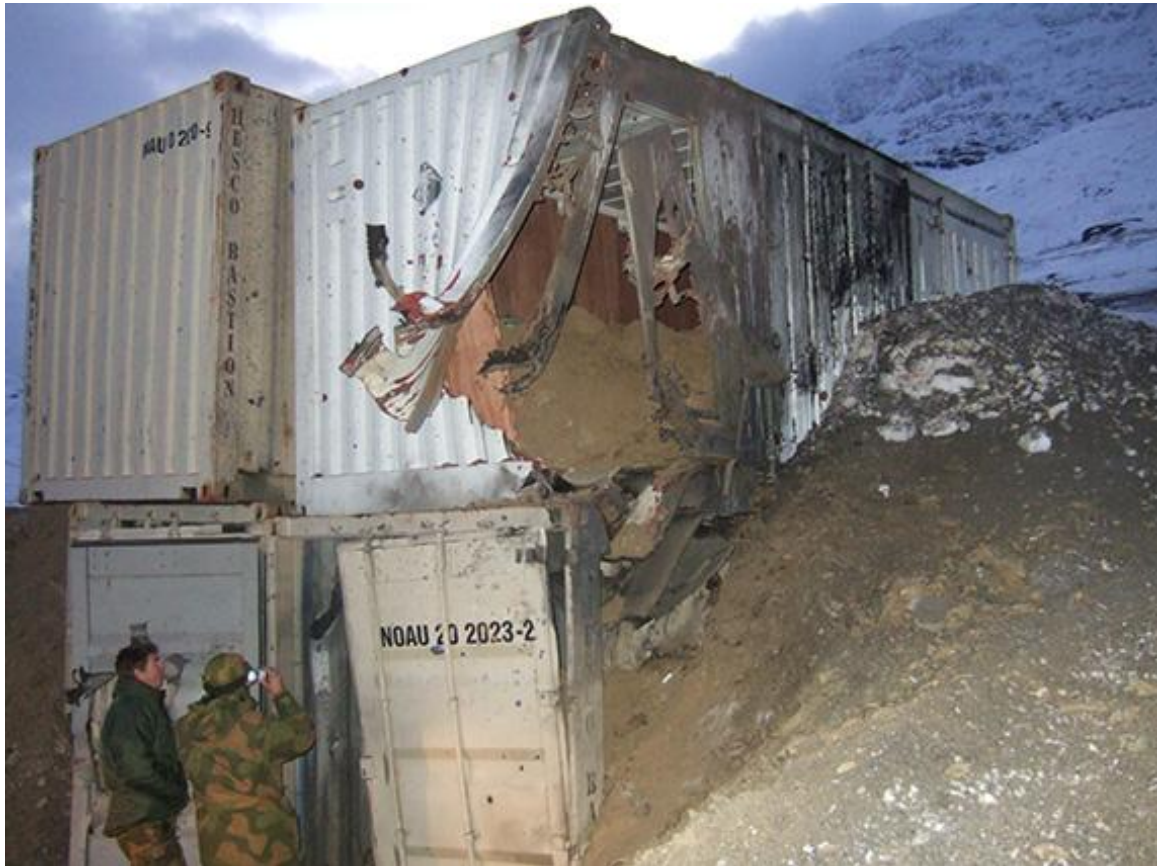
A real weapon will in general not have the same effect on a target as a bare charge. To test the effect of real weapons 155 mm artillery shells were fired against the UTOPS shelter and an INTOPS shelter. One shot hit the target, see figure 2.31.

Figure 2.31 Results of a direct hit by a 155 shell at an INTOPS shelter

When weapon threats are simulated by contact detonation of bare charges, the impact load, the enhanced effect of a buried charge and the damping by the casing is not included. Therefore the effect of a hit by a real weapon is probably larger. Live firings were made to explore the differences, but all except one missed the targets.
